**AFTER ACTION REPORT
FOR
DAM BREACHING**

**Pigg River Power Dam
Franklin County, Virginia**

January 2018

Prepared by:
David Byrd
Coordinator, Virginia Partners for Fish and Wildlife Program
U.S. Fish and Wildlife Service
6669 Short Lane

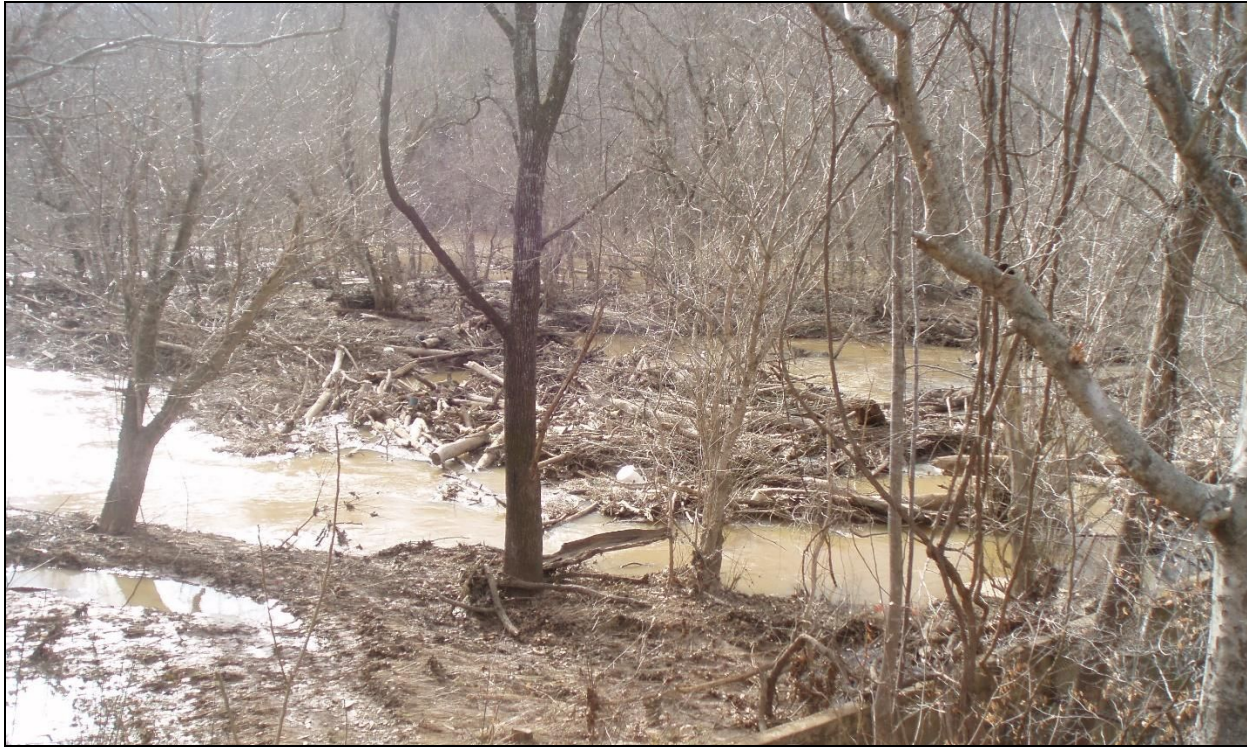
An estimated 3,000 yd³ of woody debris was located upstream of the dam (Photo 3). Quantities were based upon field observation and previous coring during sediment quantity and quality analysis. During breaching operations, the contractor began removal of the woody material to allow the river channel to return to pre-removal dimensions and completed woody debris removal after breaching was complete (Photos 13 and 15). Woody debris consisted of living trees, trunks and branches at the surface, and degraded into decomposed material at depth. Larger logs and branches were removed and stockpiled at a nearby location (Photo 16), prior to being transported offsite for disposal. Due to the degraded condition of the lower layers of woody debris, substantially less woody debris was removed than the anticipated.

3. Woody debris upstream of Power Dam blocking river channel pre-breach, causing adjacent flooding (1/26/06)

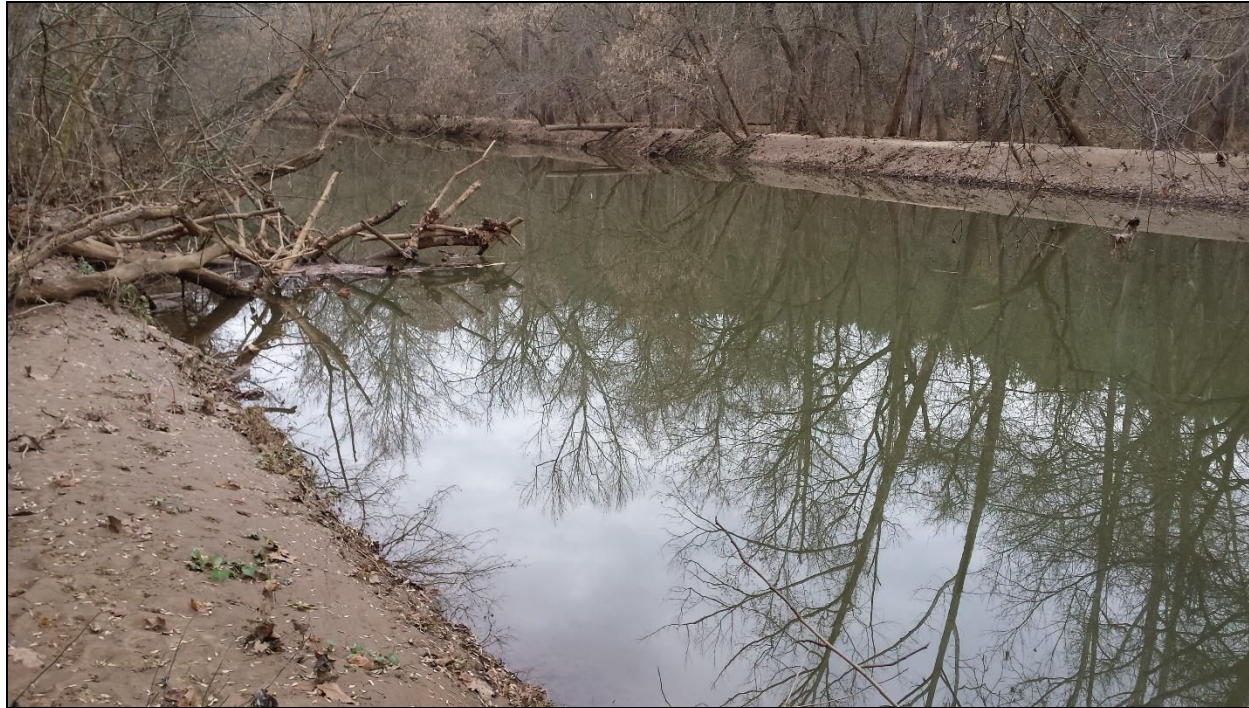
4. Typical levee formations on both right and left banks upstream of Power Dam pre-breach (11/17/15)

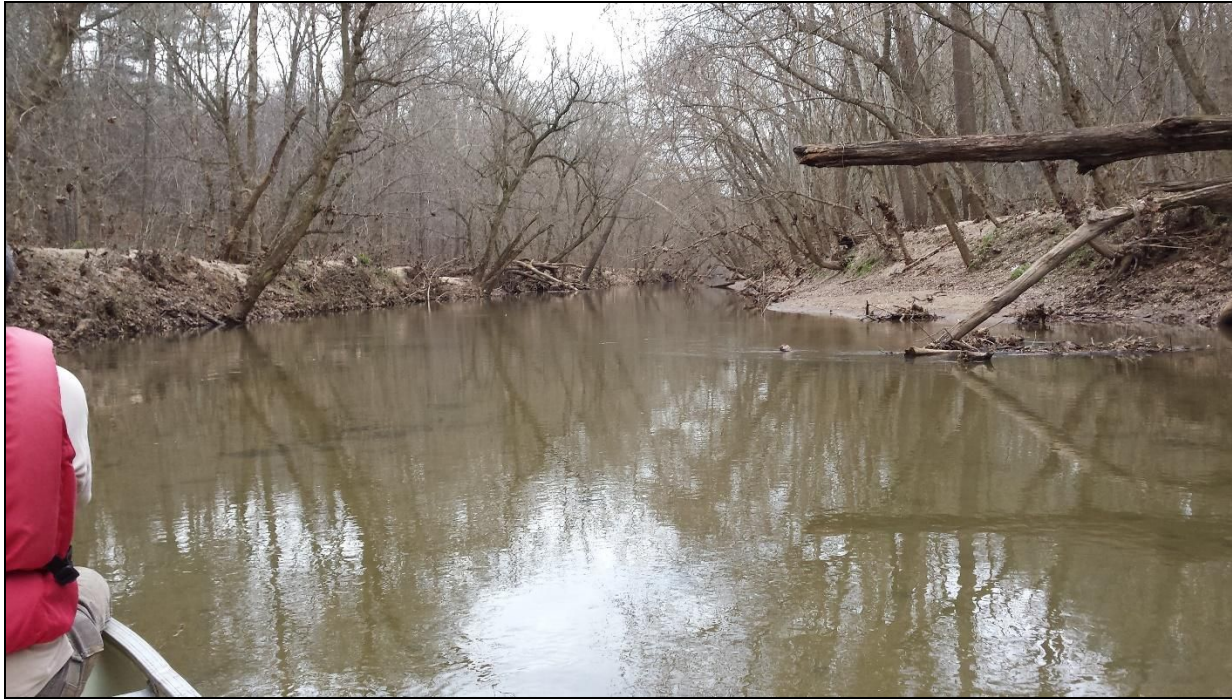
5. Typical upstream river channel within pool with high levees and shallow, sediment filled channels (11/17/15)

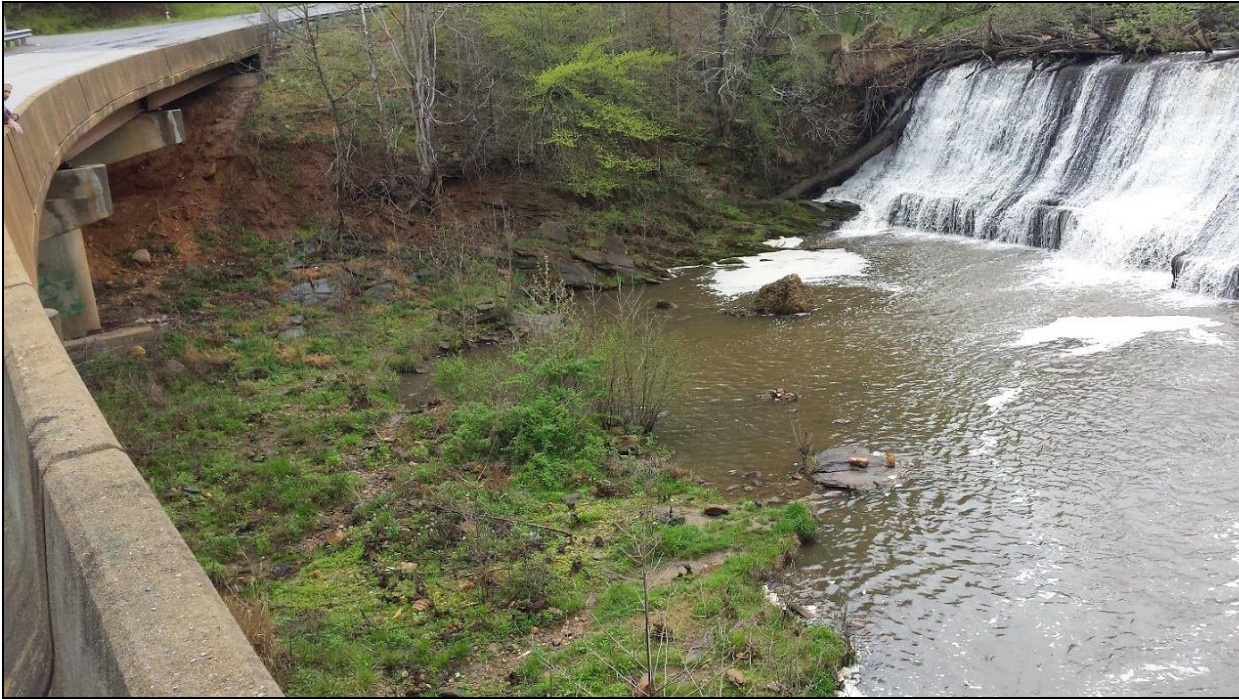
6. Over-widened channel and scour hole on right bank below Power Dam, view east (4/16/15)

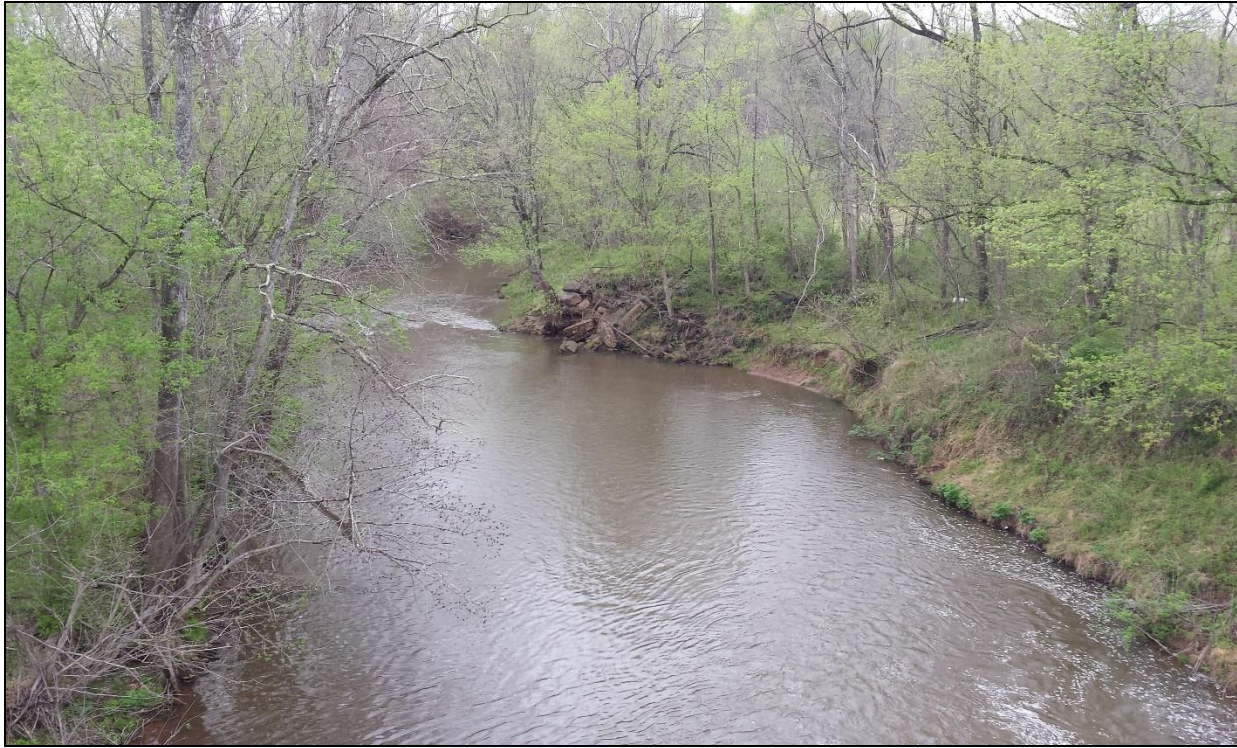
7. View north, downstream of Power Dam depicting over-widened, sediment starved channel (4/16/15)

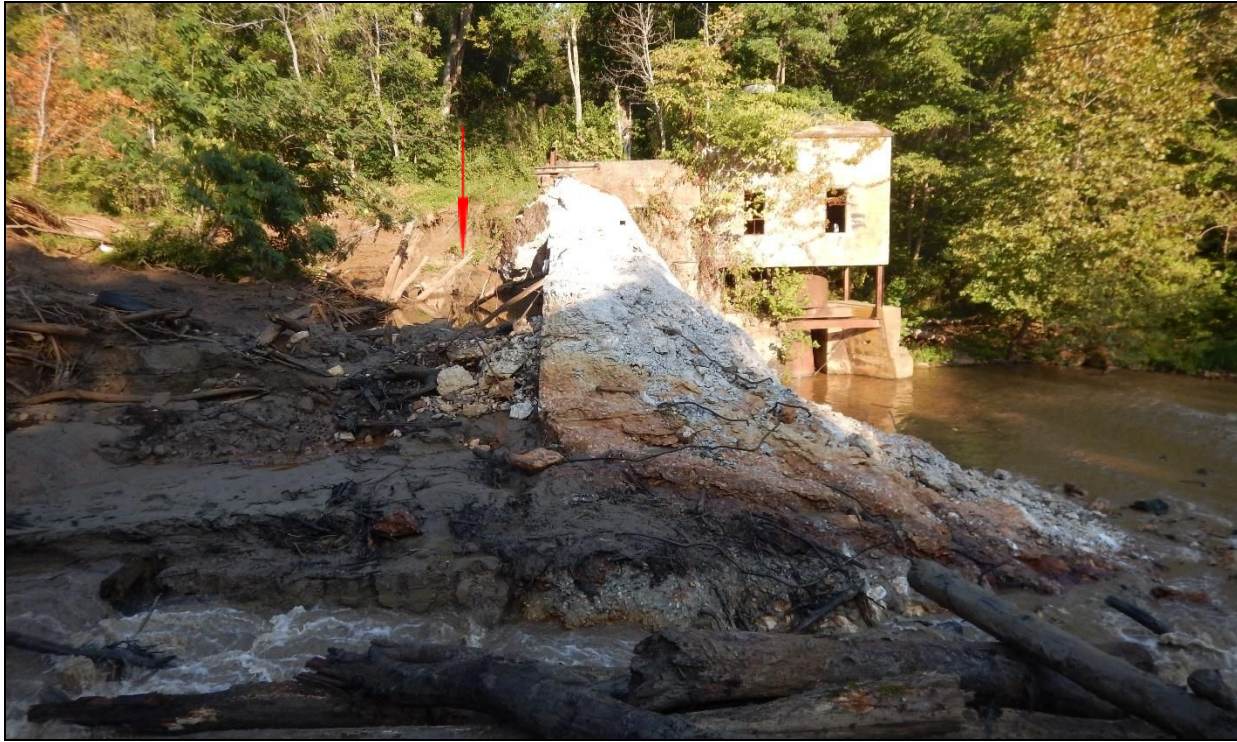
14. Exposure of existing scour hole (red arrow) above Power Dam, potentially leading to wetland headcut (9/7/16)

During breaching operations, an area immediately upstream of the dam on river left (adjacent to the powerhouse) was identified as having a significant scour hole due to turbulent flow adjacent to the dam prior to breaching (Photo 14). Additional scouring and bank failure after breaching threatened to form a headcut into the 9-acre wetland, effectively draining it. Restoration of the slope was completed through placement of stacked stone toe protection on September 20, 2016. Backfilling the scour hole to restore a stable slope configuration, placement of coir matting, and seeding with a native seed mix was completed on September 27, 2017.

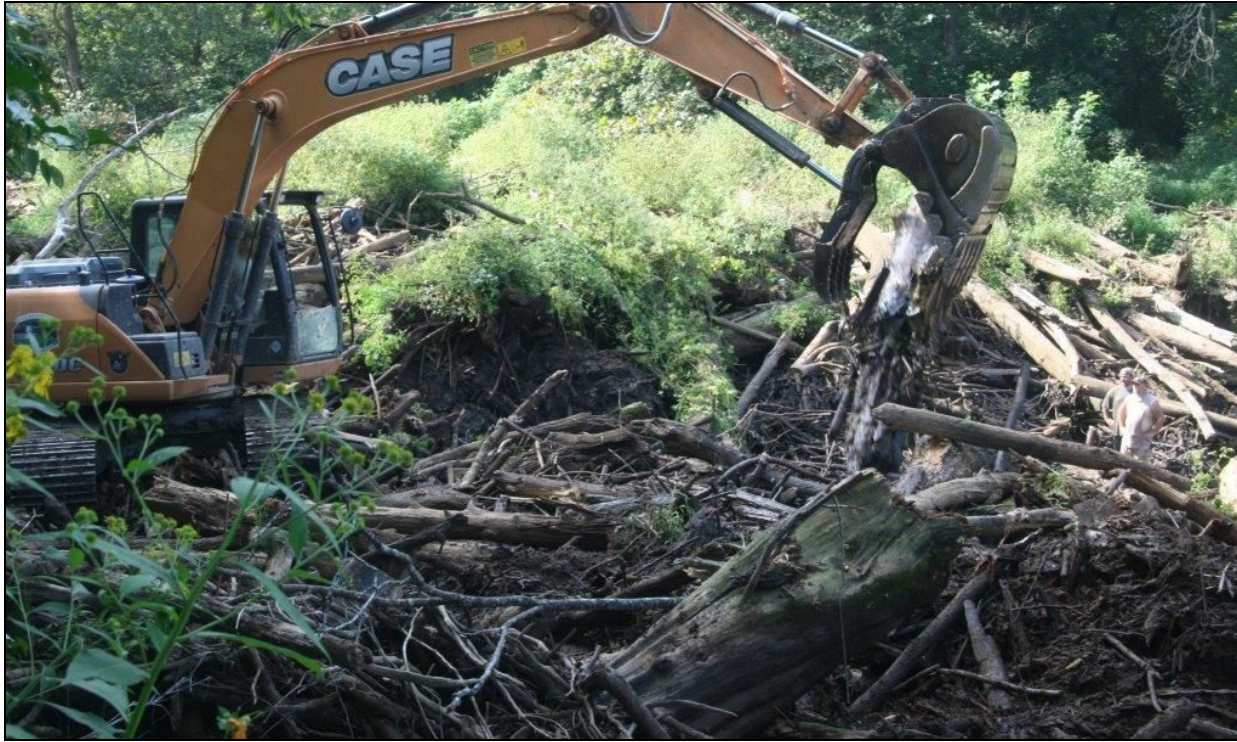
15. Removal of woody debris above Power Dam (9/9/16)

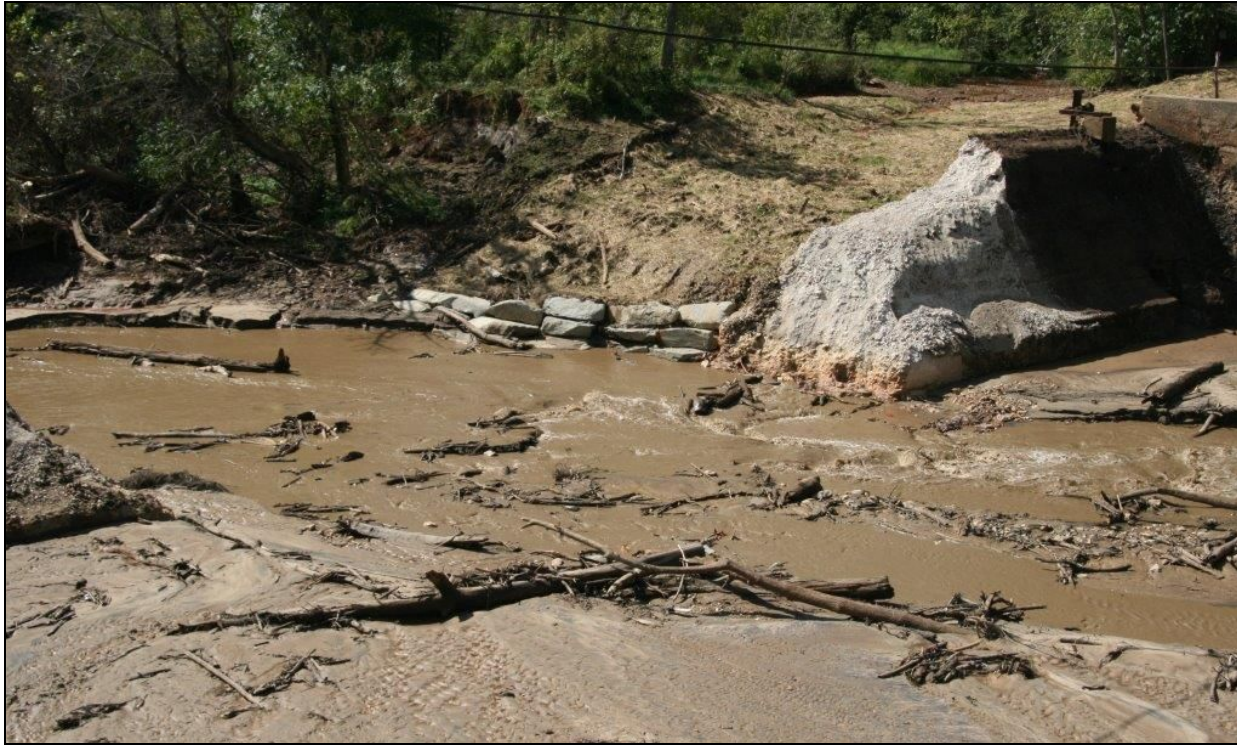
24. View of left bank upstream of dam after stacked stone toe, backfilling, and matting stabilization (10/5/16)

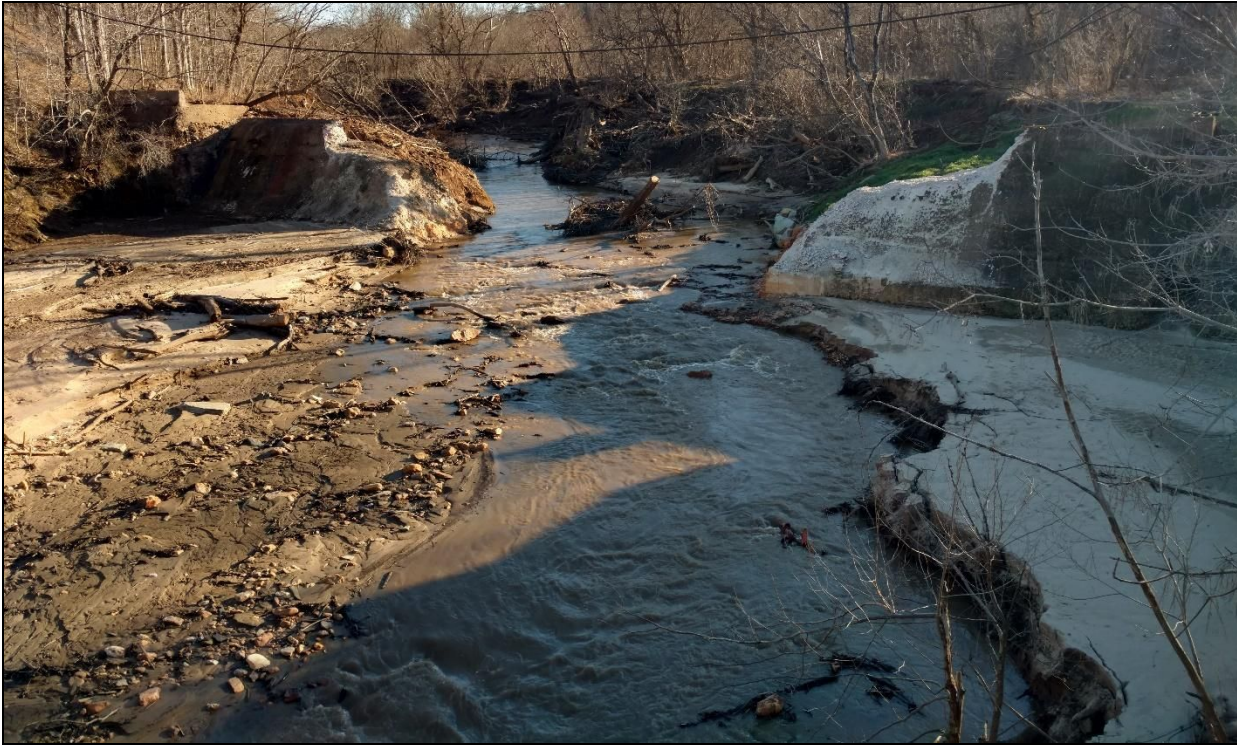
Site restoration initially consisted of grading the proposed wetland restoration site and removal of the structural erosion and sedimentation controls. Subsequent flood flow deposition added approximately 3-4 ft of elevation to the proposed wetland restoration area, effectively precluding any potential for wetland restoration, though reestablishing a more stable floodplain elevation (Photos 25 and 26). The improved

26. Floodplain deposition on left and right banks below breach (2/2/17)

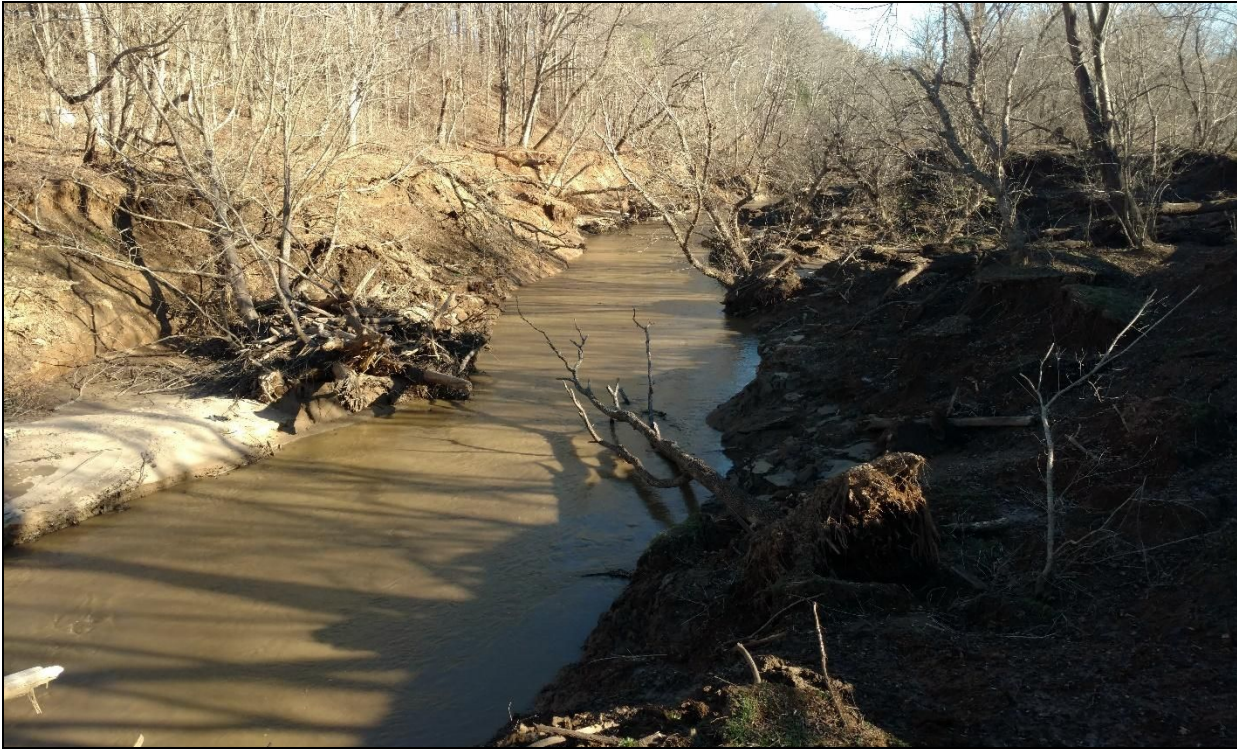
27. Bank sloughing and new floodplain bench upstream of the breach (2/2/17)

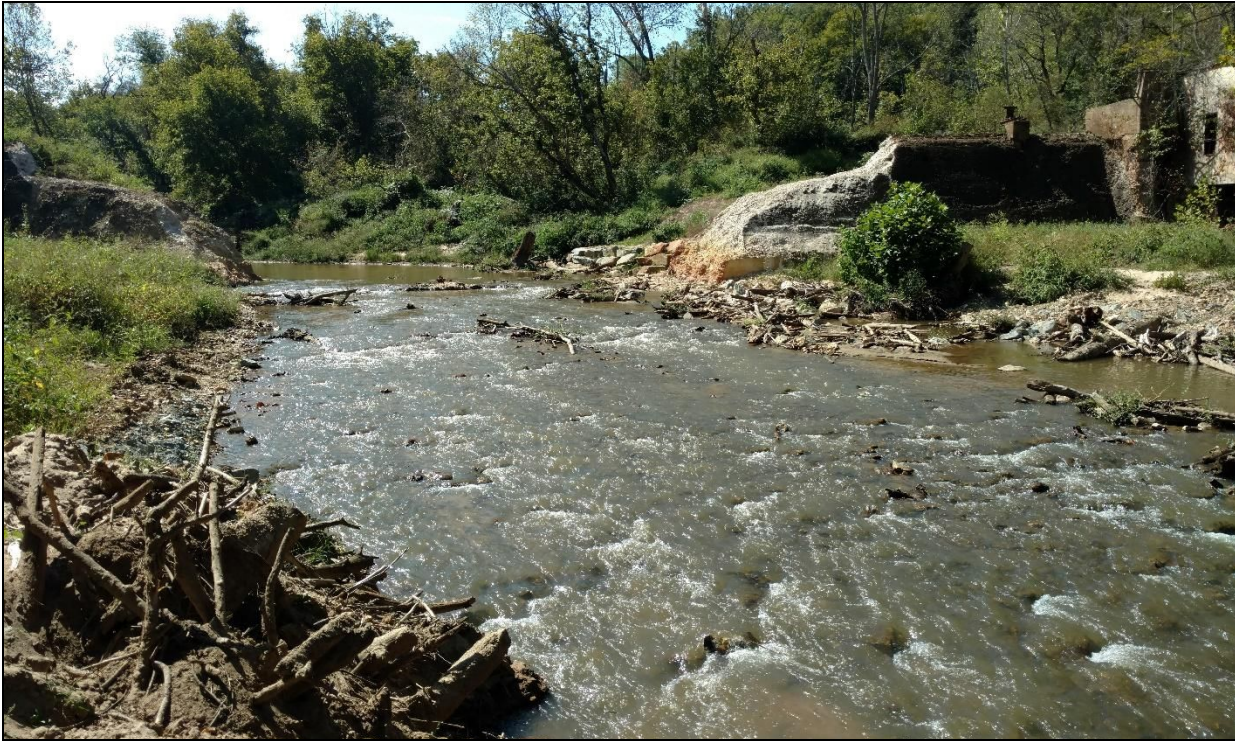
35. Riffle re-established in former scour hole below Power Dam breach (9/26/17)

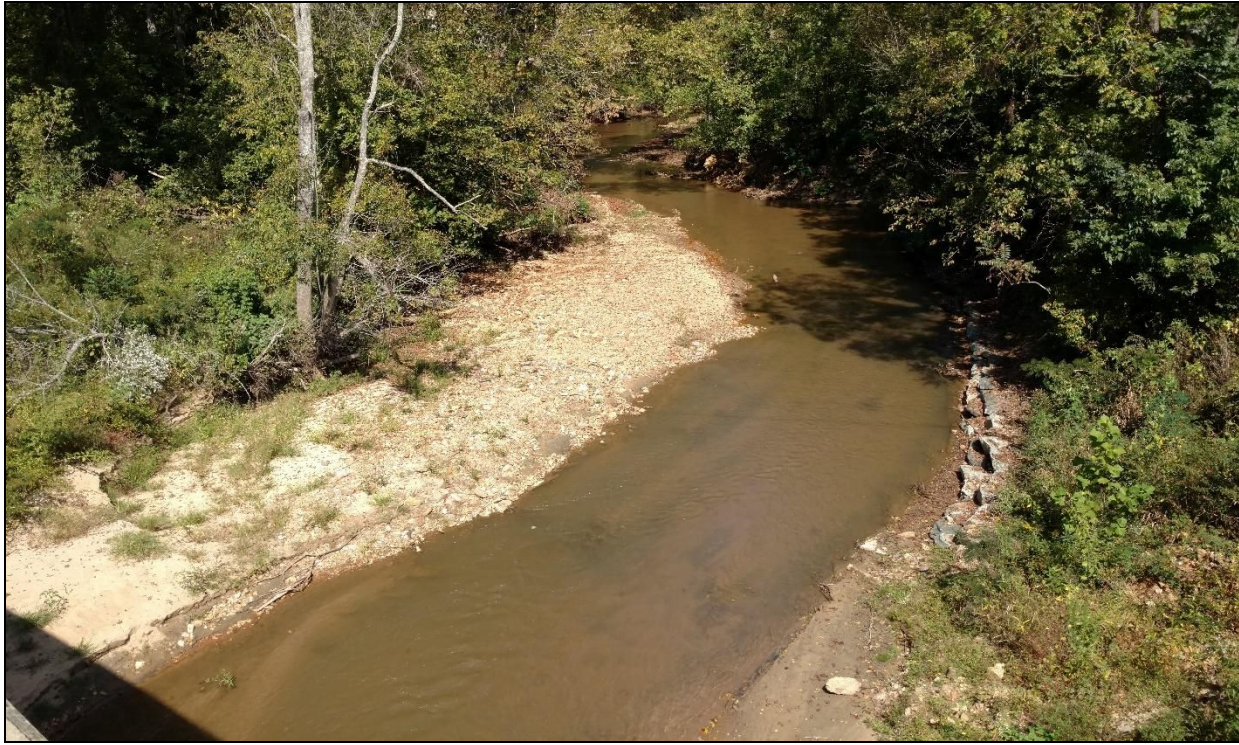
36. Stable cobble/gravel point bar on the inside of a meander bend downstream of breach below Route 712 Bridge (9/26/17)

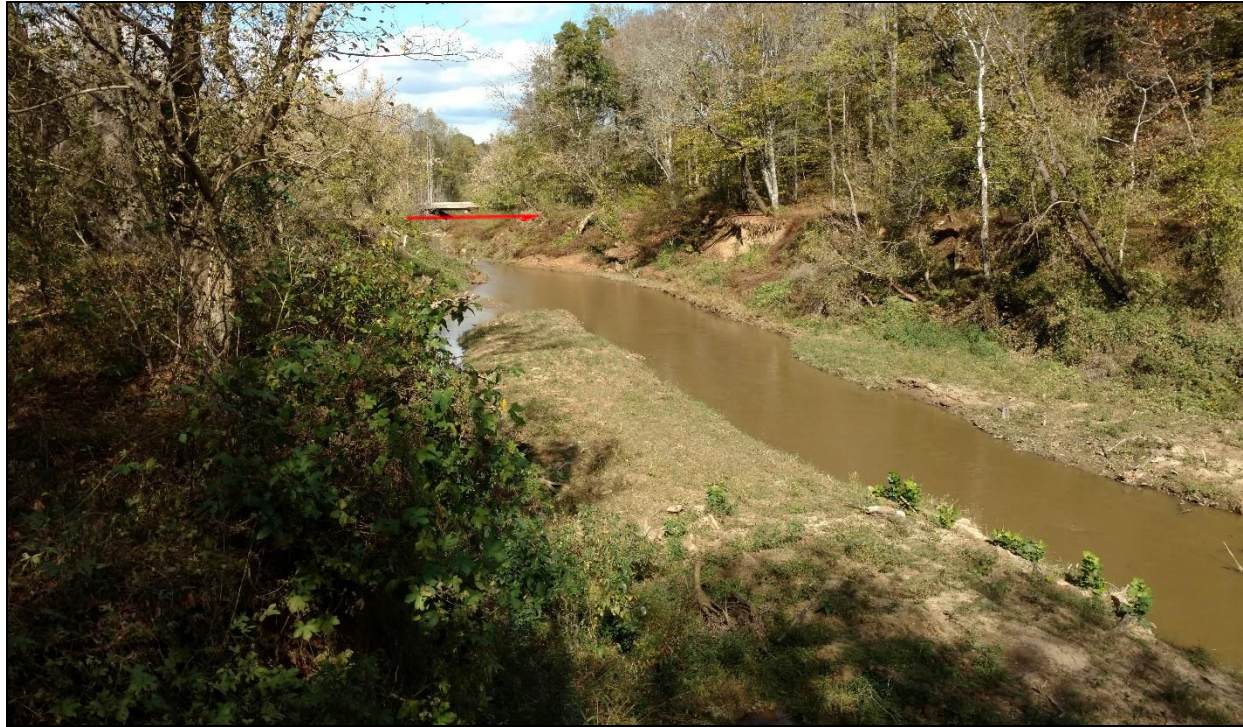
38. River channel and floodplain approximately 580 feet upstream of breach. Arrow depicts pool elevation (10/25/17)

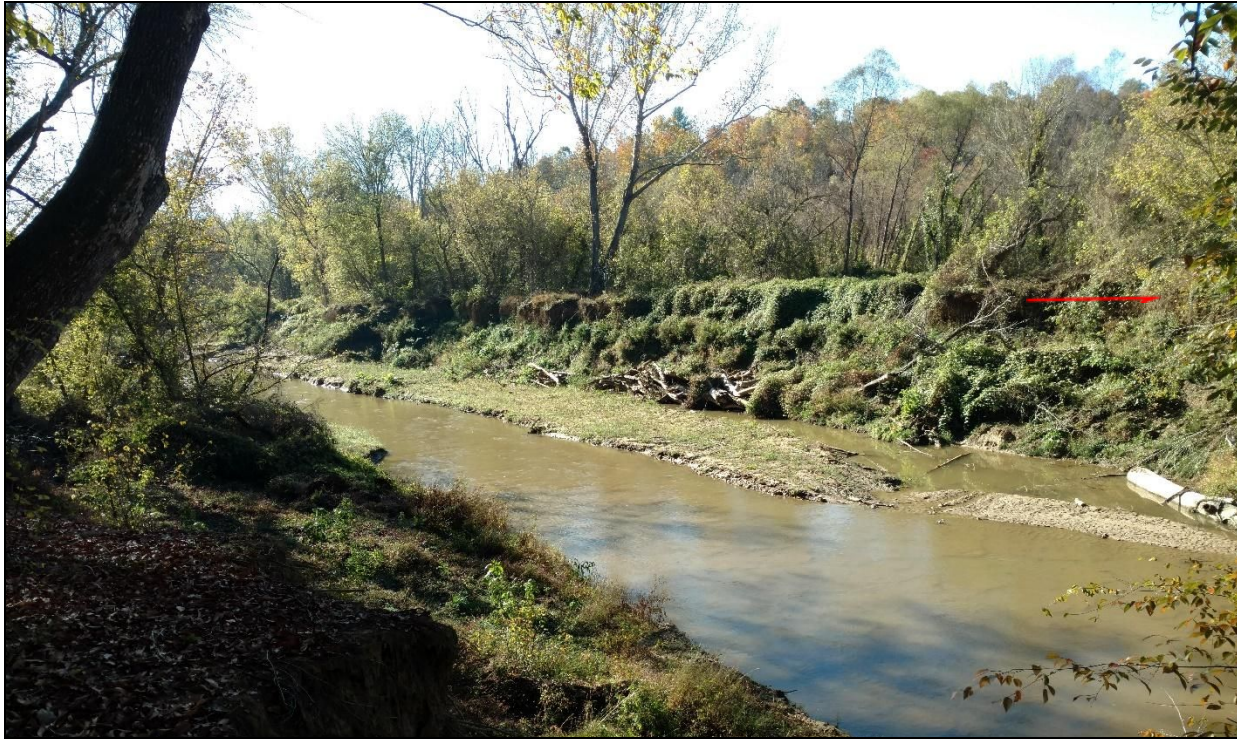
39. Same area from opposite side of the Pigg River illustrating high banks in area. Arrow depicts pool elevation (10/25/17)
